U.S. ARMY TANK-AUTOMOTIVE AND ARMAMENTS COMMAND

U.S. ARMY ARMAMENT RESEARCH, DEVELOPMENT AND ENGINEERING CENTER

Improved Manufacture of Illuminating Candles for Mortar Ammunition

44th Annual Fuze Conference & Munitions Manufacturing and Technology Symposium

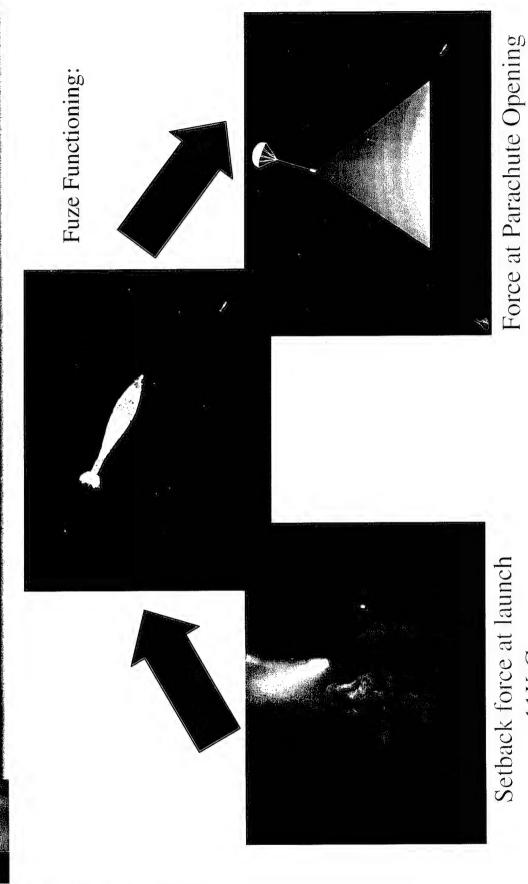
Forces Acting on 120mm Candle Assembly

- Candle Non-ignition: Candle does not ignite after fuze function and candle expulsion
- First fire composition is blown off of the cartridge candle and does not ignite
- Fracture in first fire composition from
- mortar set-back
- fuze function
- expulsion of flare
- pressing of flare composition

any combination of the above

400 Gs

11K Gs

- Root cause analysis performed to identify probable causes:
- problem with binder in first fire composition
- replace solvent
- Need to develop better ignition train
- concave punch (Embedded for 81mm)
- 50/50 transitional mixture of first fire and flare composition
- Handling of the FF mix.

Following incorporation of the above the non-ignition problem has been eliminated
